TCLink

Design choice
Slave Rx recovered clock for Rev1.1

25/02/2020

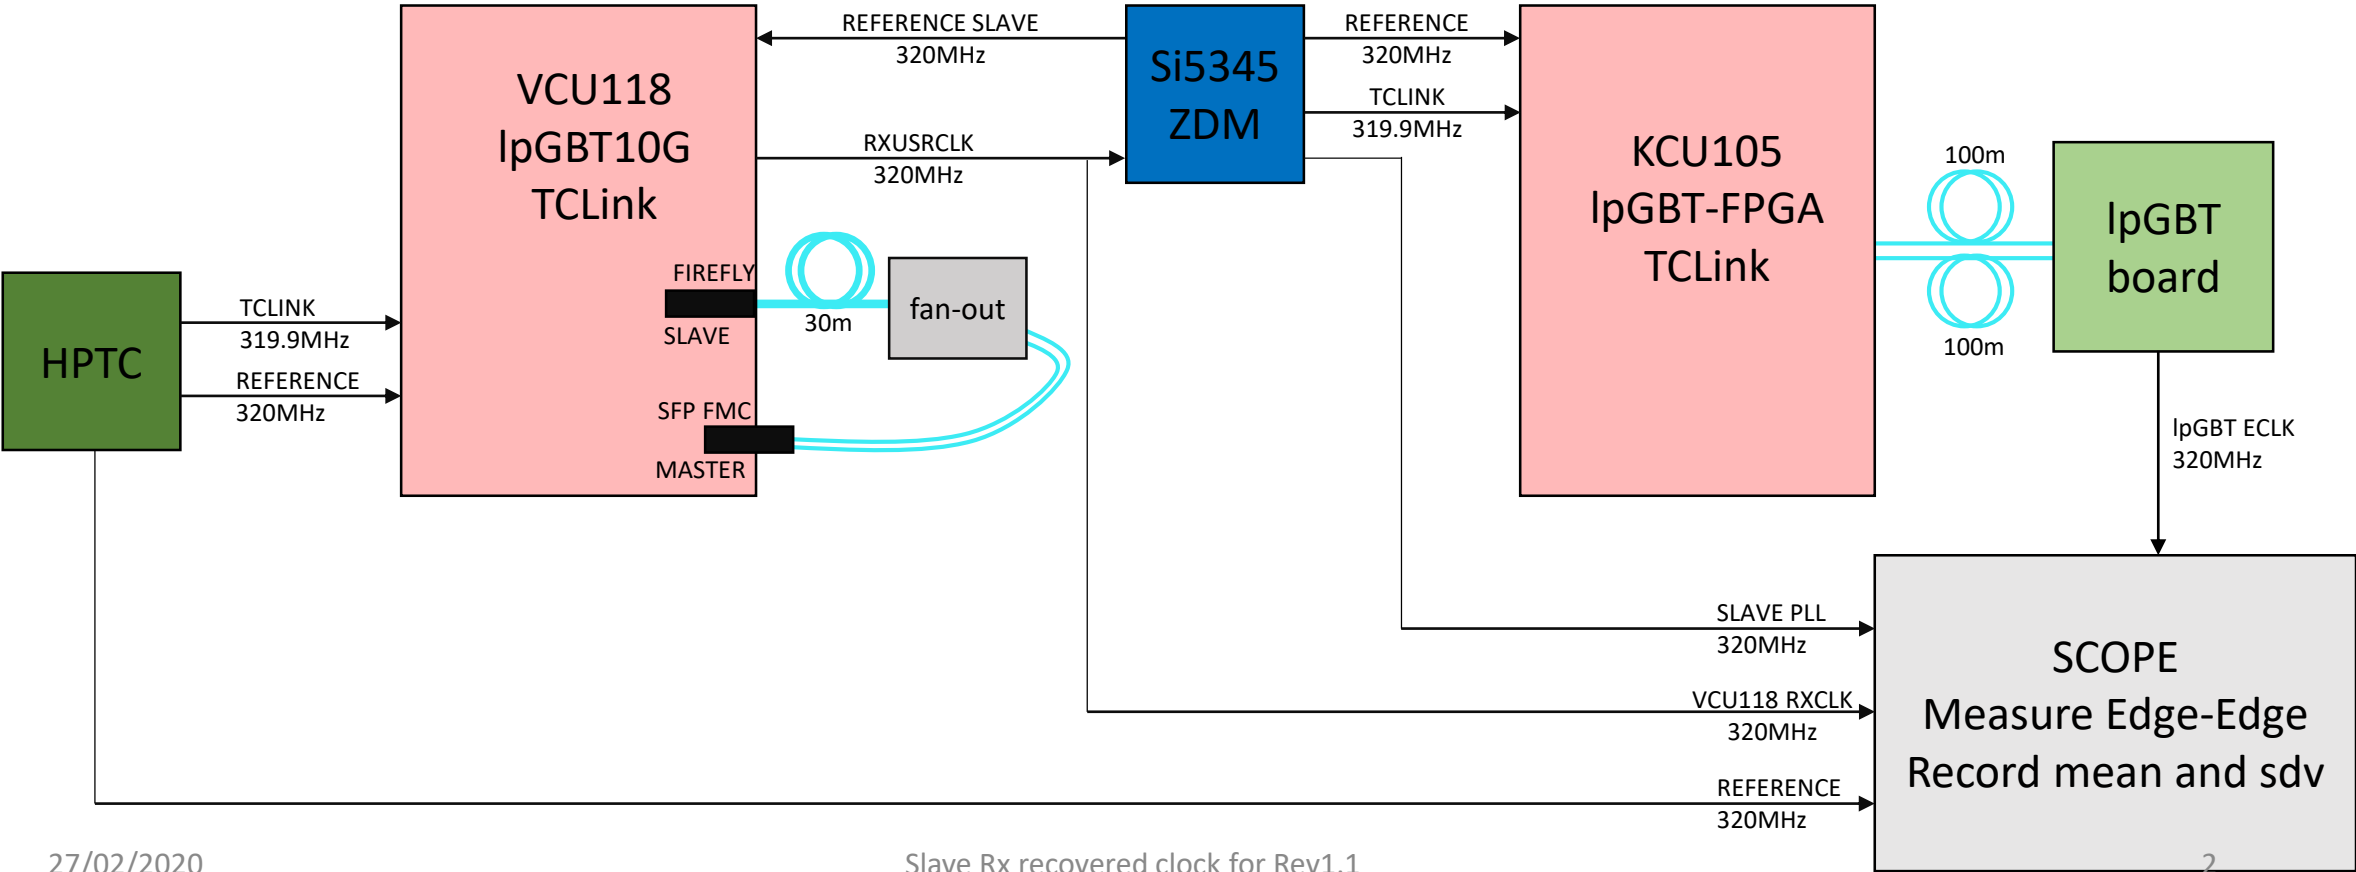
- During TCLink system reset tests to observe phase-determinism...

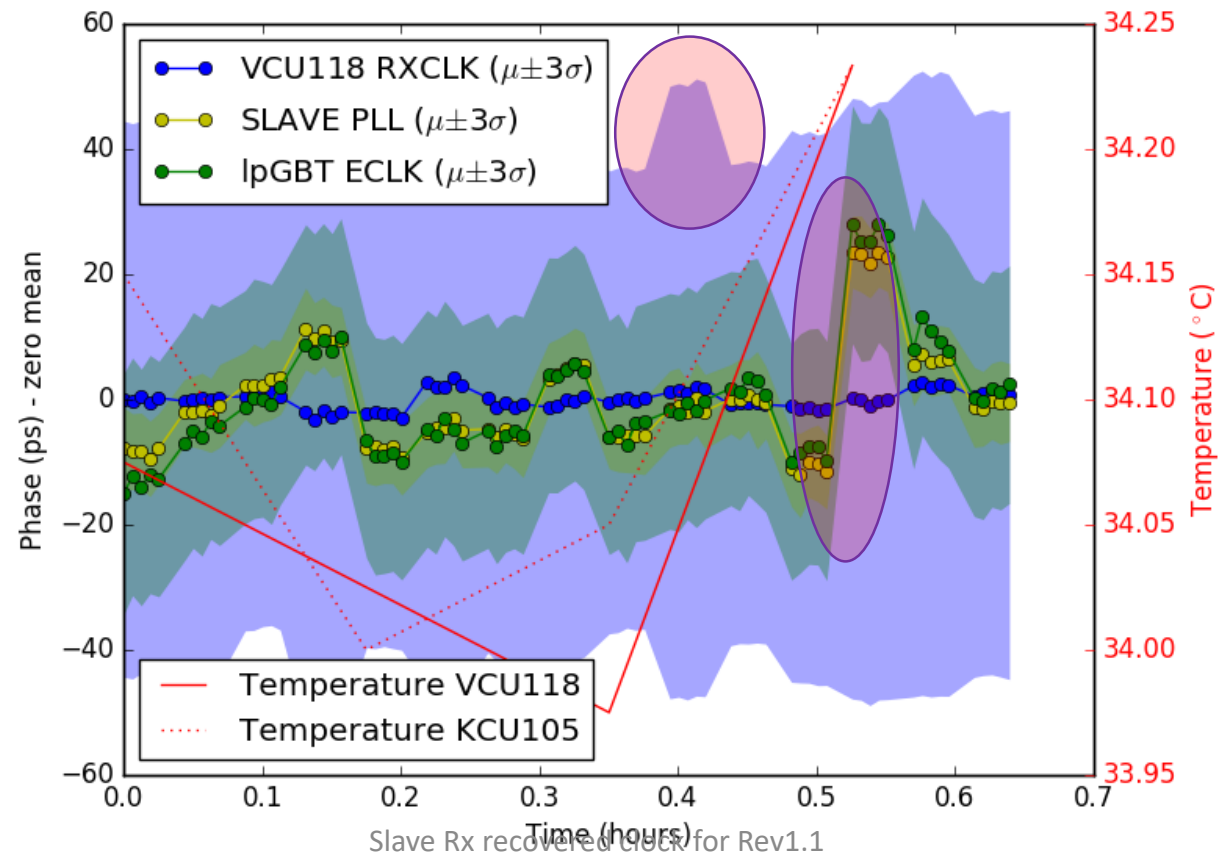
- ...an unexpected behavior was observed with resets!
 - Phase mean jumps of clock from Si5345 and Standard deviation jumps from VCU118 clock
 - OBS: one reset of full-chain every five acquisitions

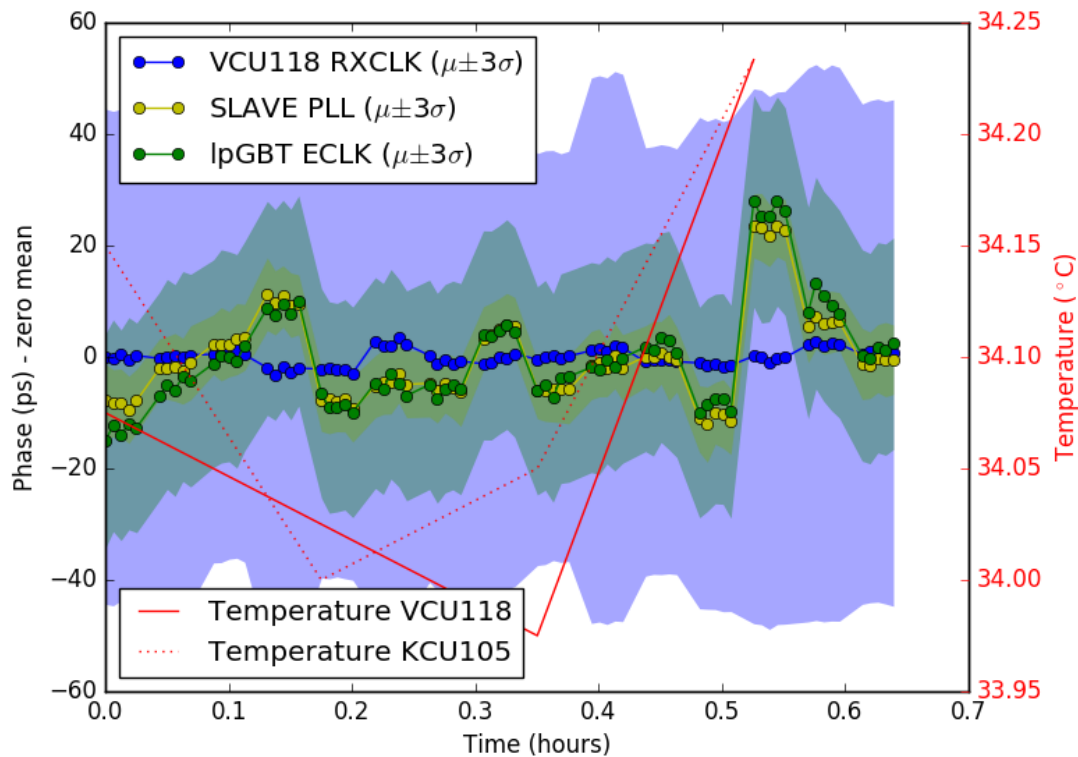
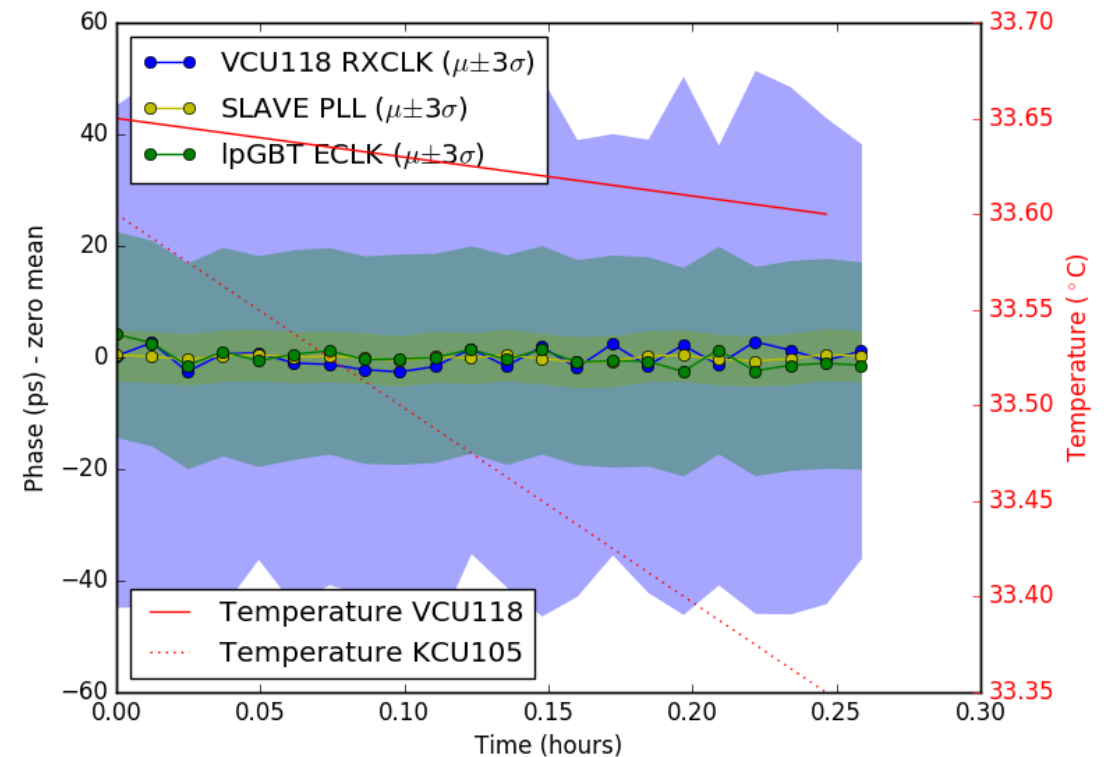
- Different hypothesis tried – same problem observed:
 - Shorter fibers, start resetting PLL, change zdm cable, no ddmtd clock slave/master
- Finally tested with Si5345 input as clock coming from HPTC: no problem observed

RXCLK as input of PLL

HPTC as input of PLL

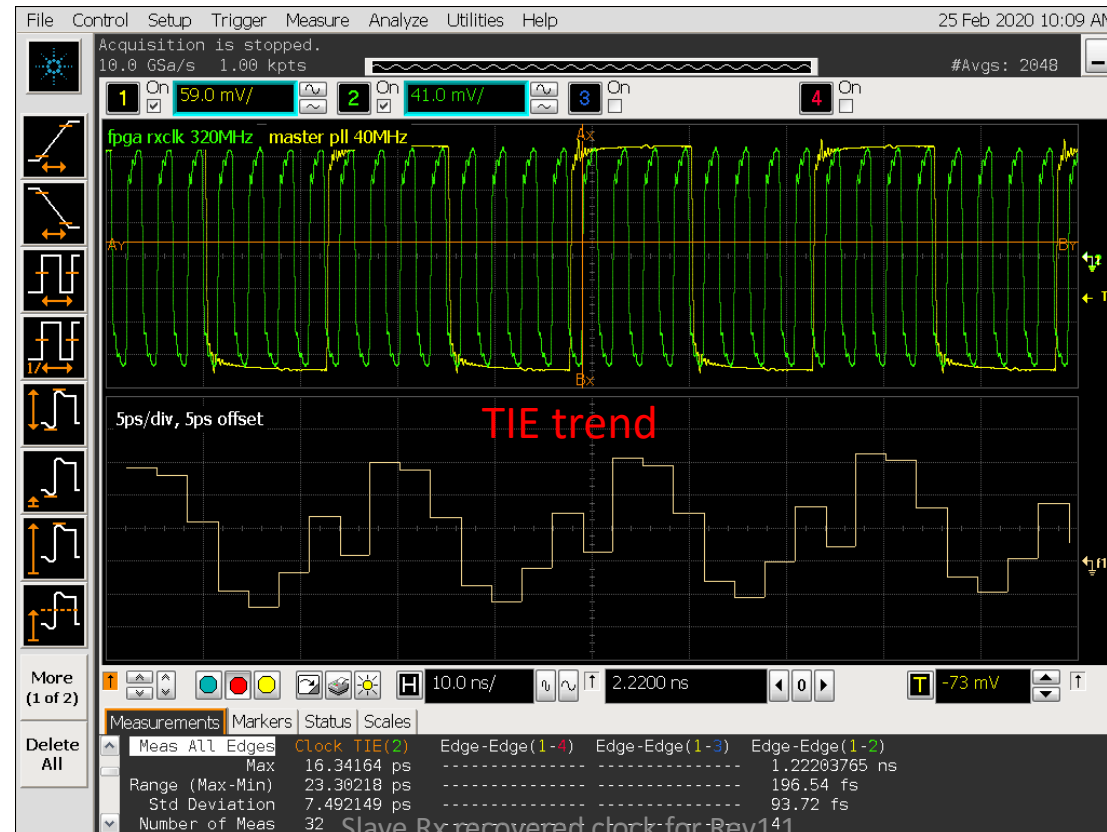
- It would be unlikely a random-like jitter could cause such a phase-jump, so we decided to observe the TIE of the RXCLK synchronized to a 40MHz master PLL clock (from HPTC)
 - This is likely related to coupling between fabric (clocked at 320MHz but using a clock enable at 40MHz) and clock-tree

The acquisition is averaged, so random noise is removed

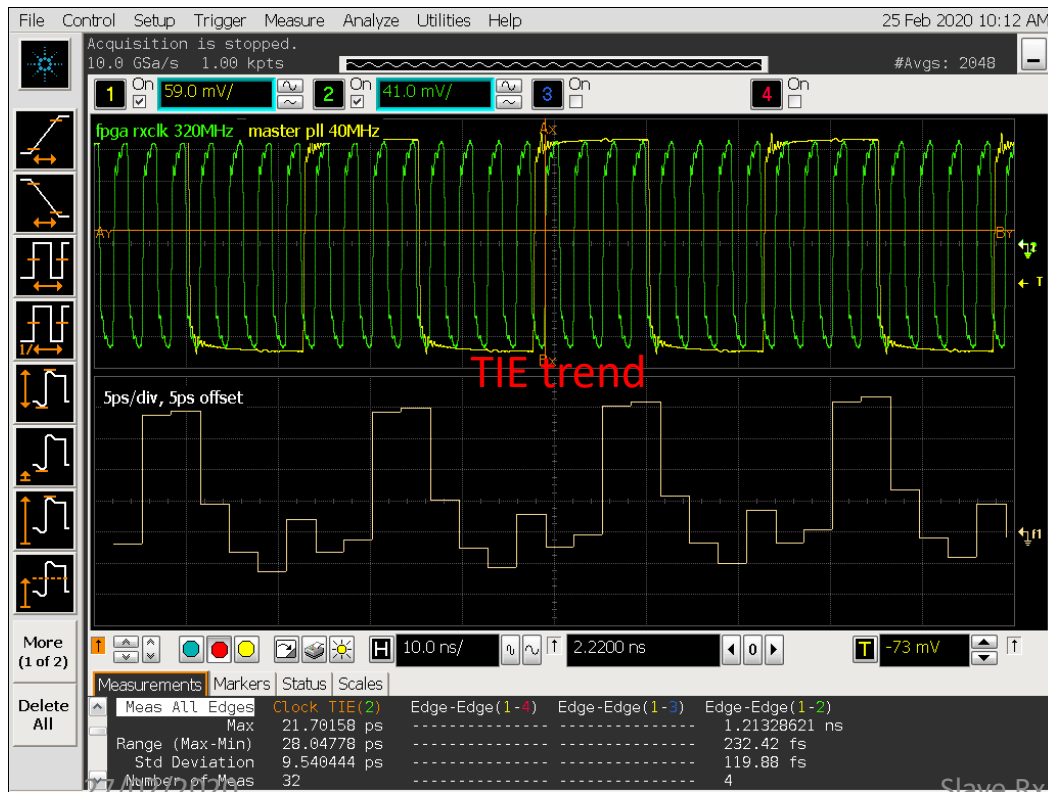
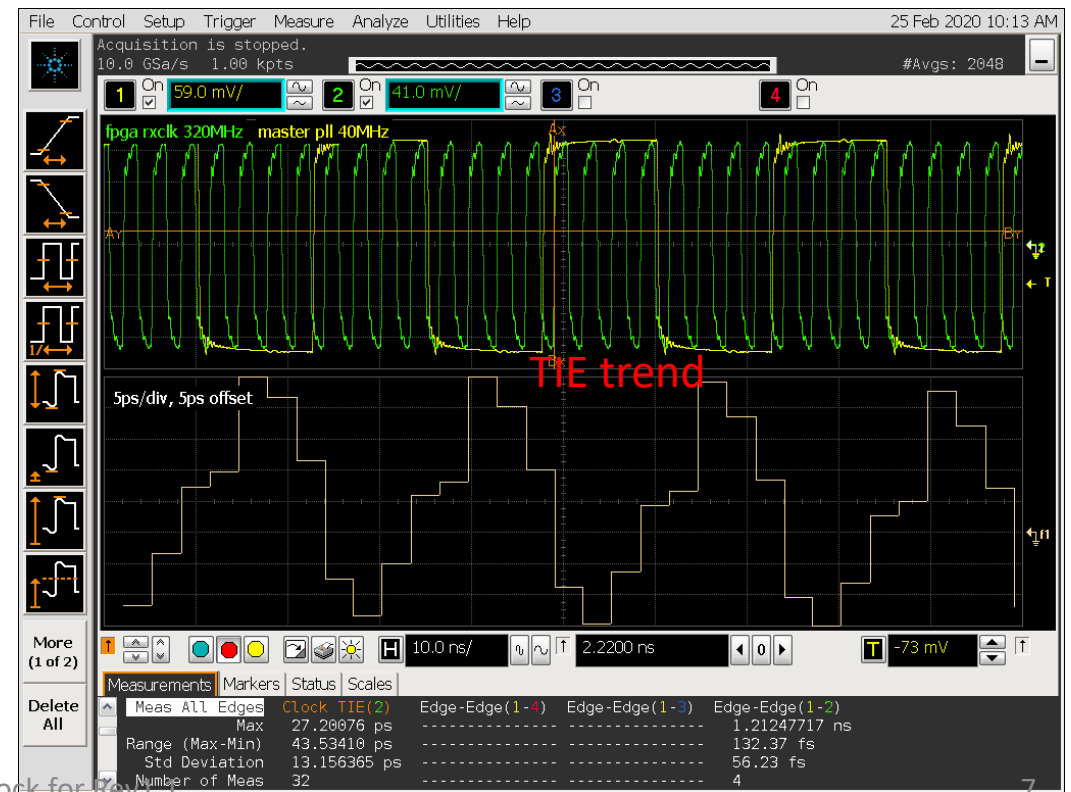
- Just by resetting the uplink logic in the fabric (i.e. not resetting the downlink at all), the TIE pattern changes:
 - Likely related to the fact that the slave Tx logic strobe is not phase-fixed with respect to the Rx logic strobe
 - This explains why the standard deviation of RXCLK changes with reset...

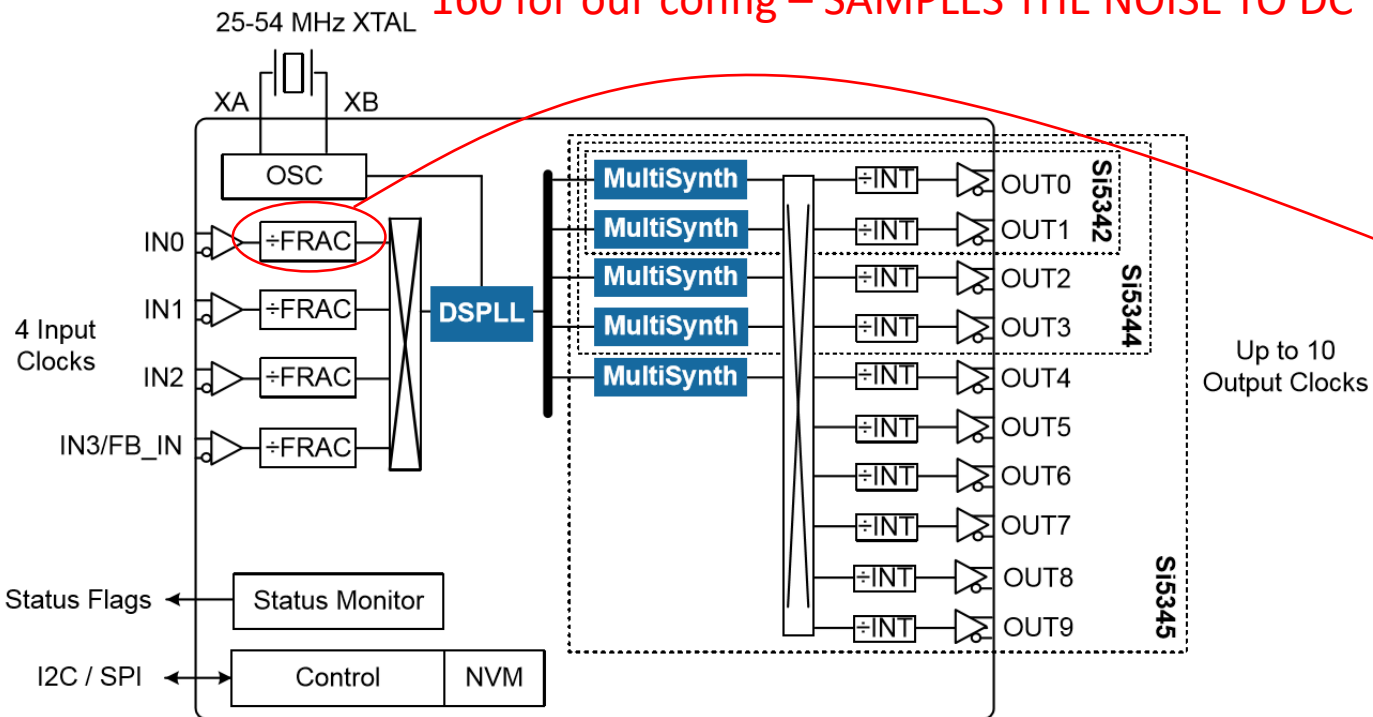
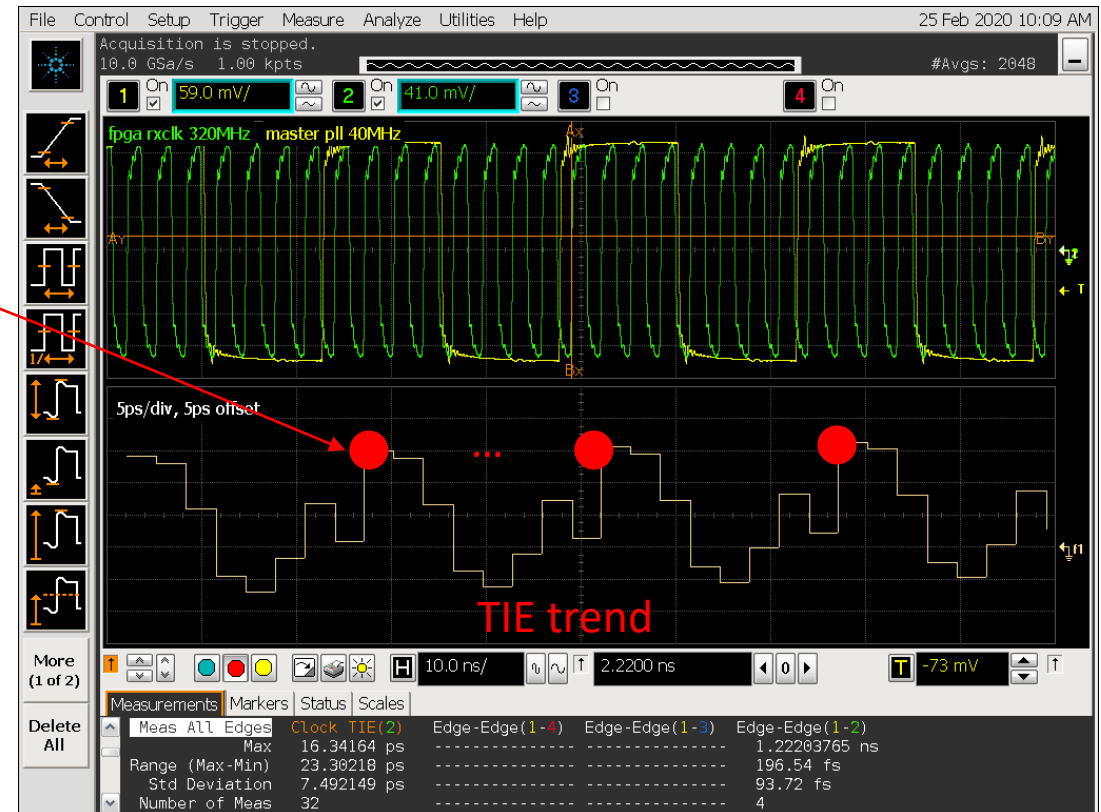
- Just by resetting the uplink logic in the fabric (i.e. not resetting the downlink at all), the TIE pattern changes:
 - ... so does it explain the phase-determinism problem with the PLL

160 for our config – SAMPLES THE NOISE TO DC

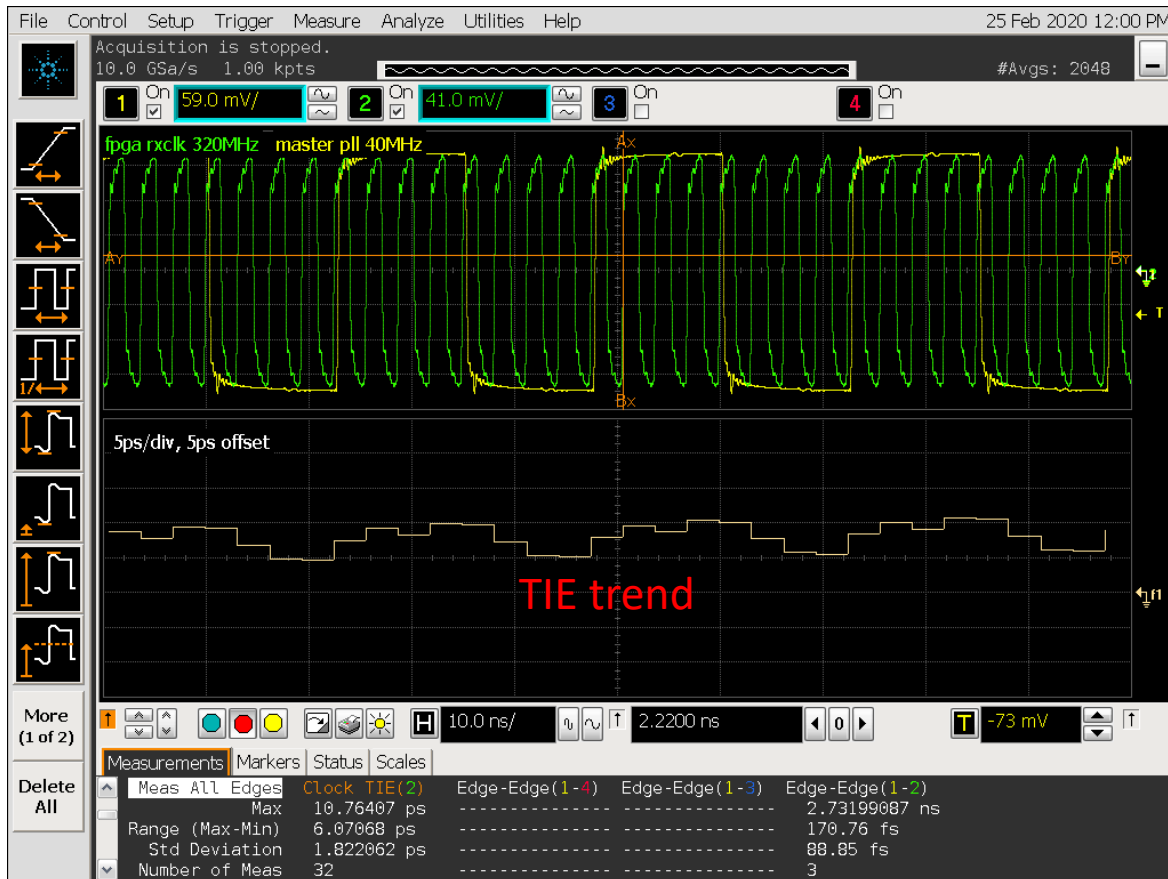
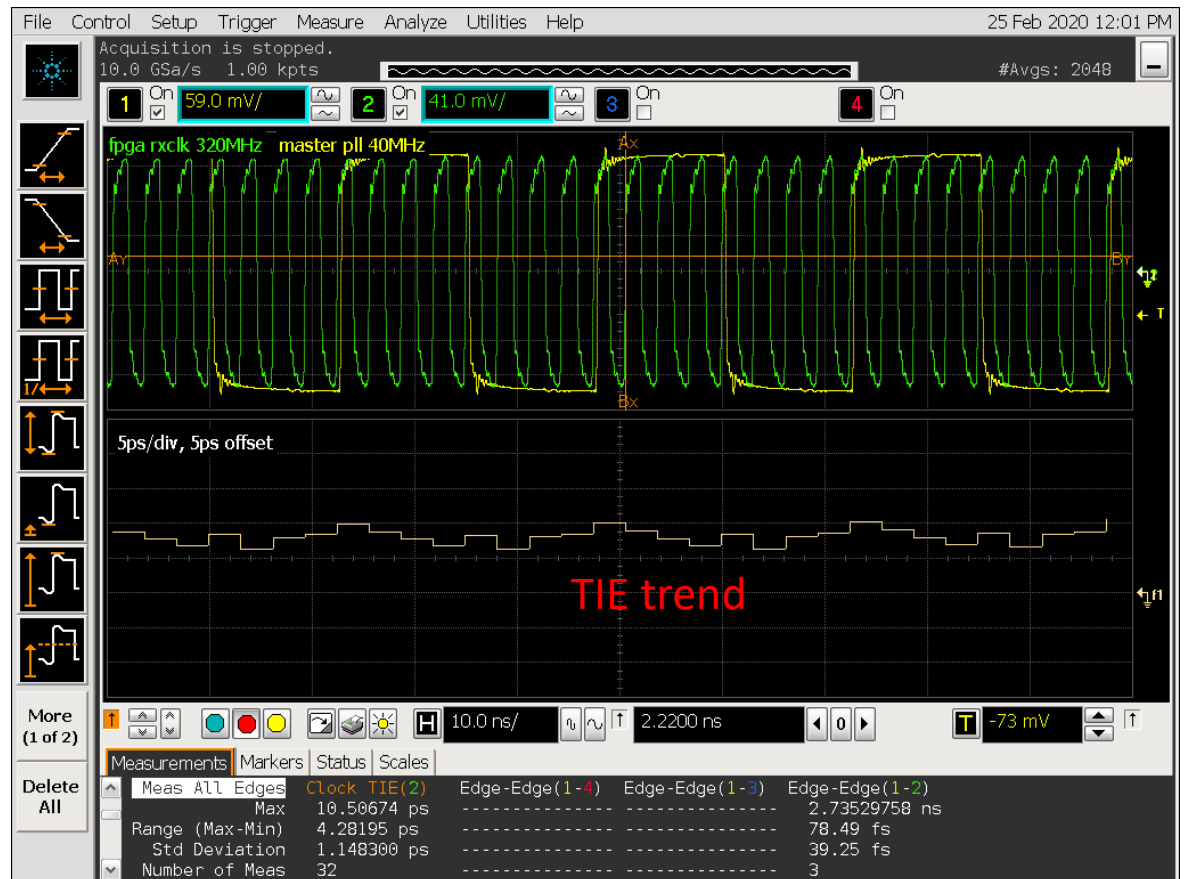
- TIE pattern is already improved but still some remaining effect
 - Probably there is still some coupling at the ODDR/output buffer/board level

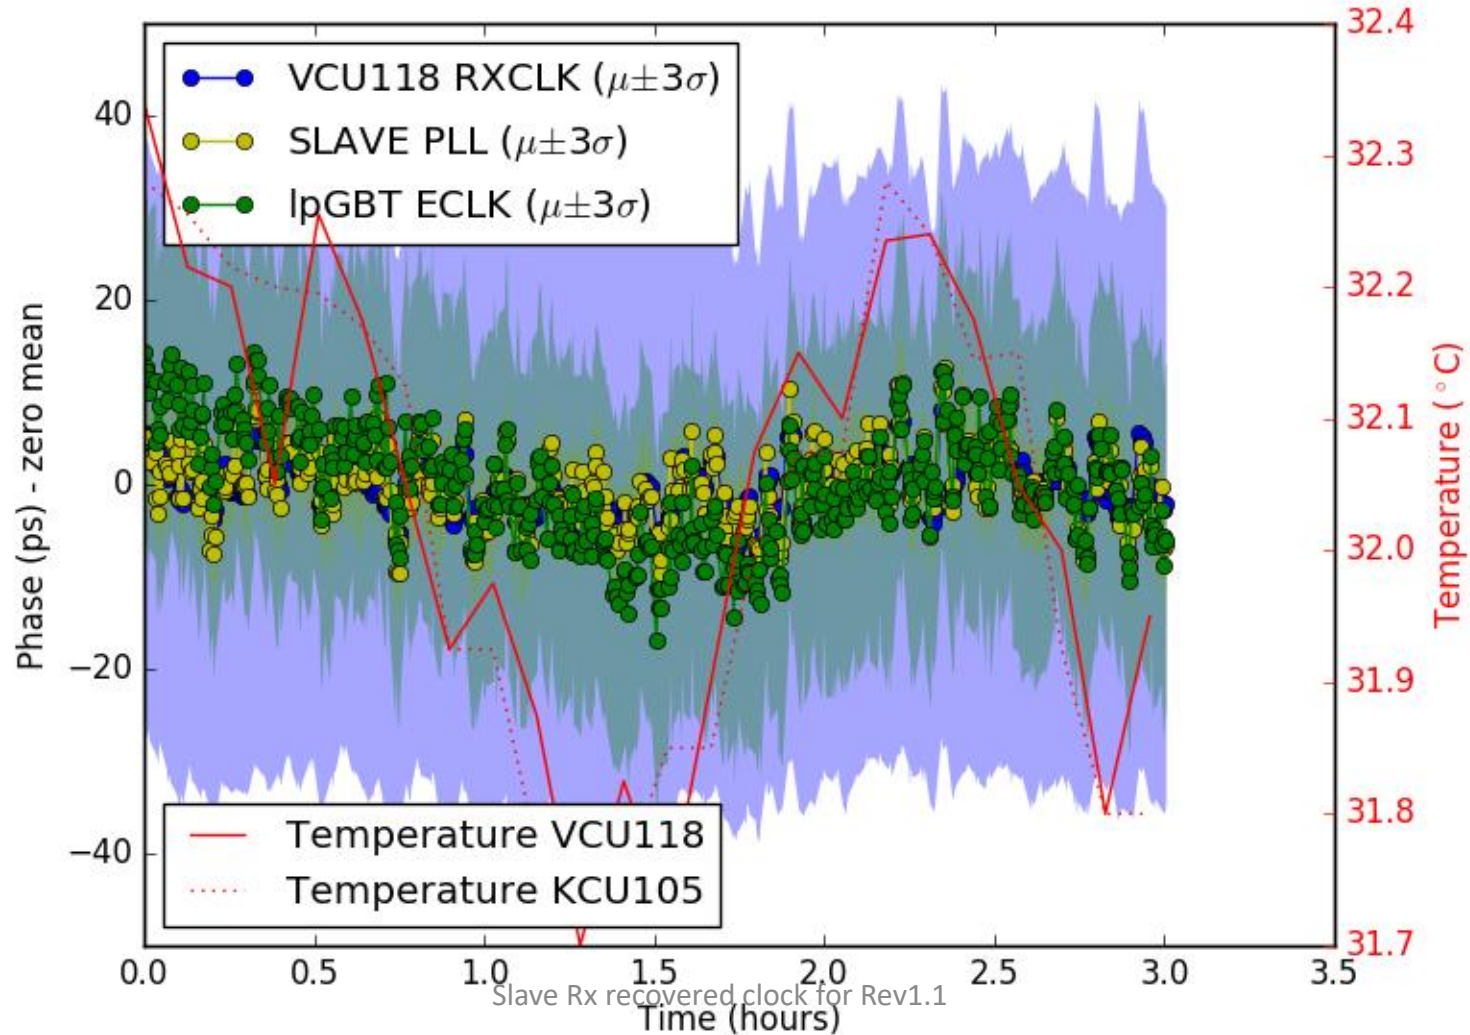
- Quite stable results for few hours...

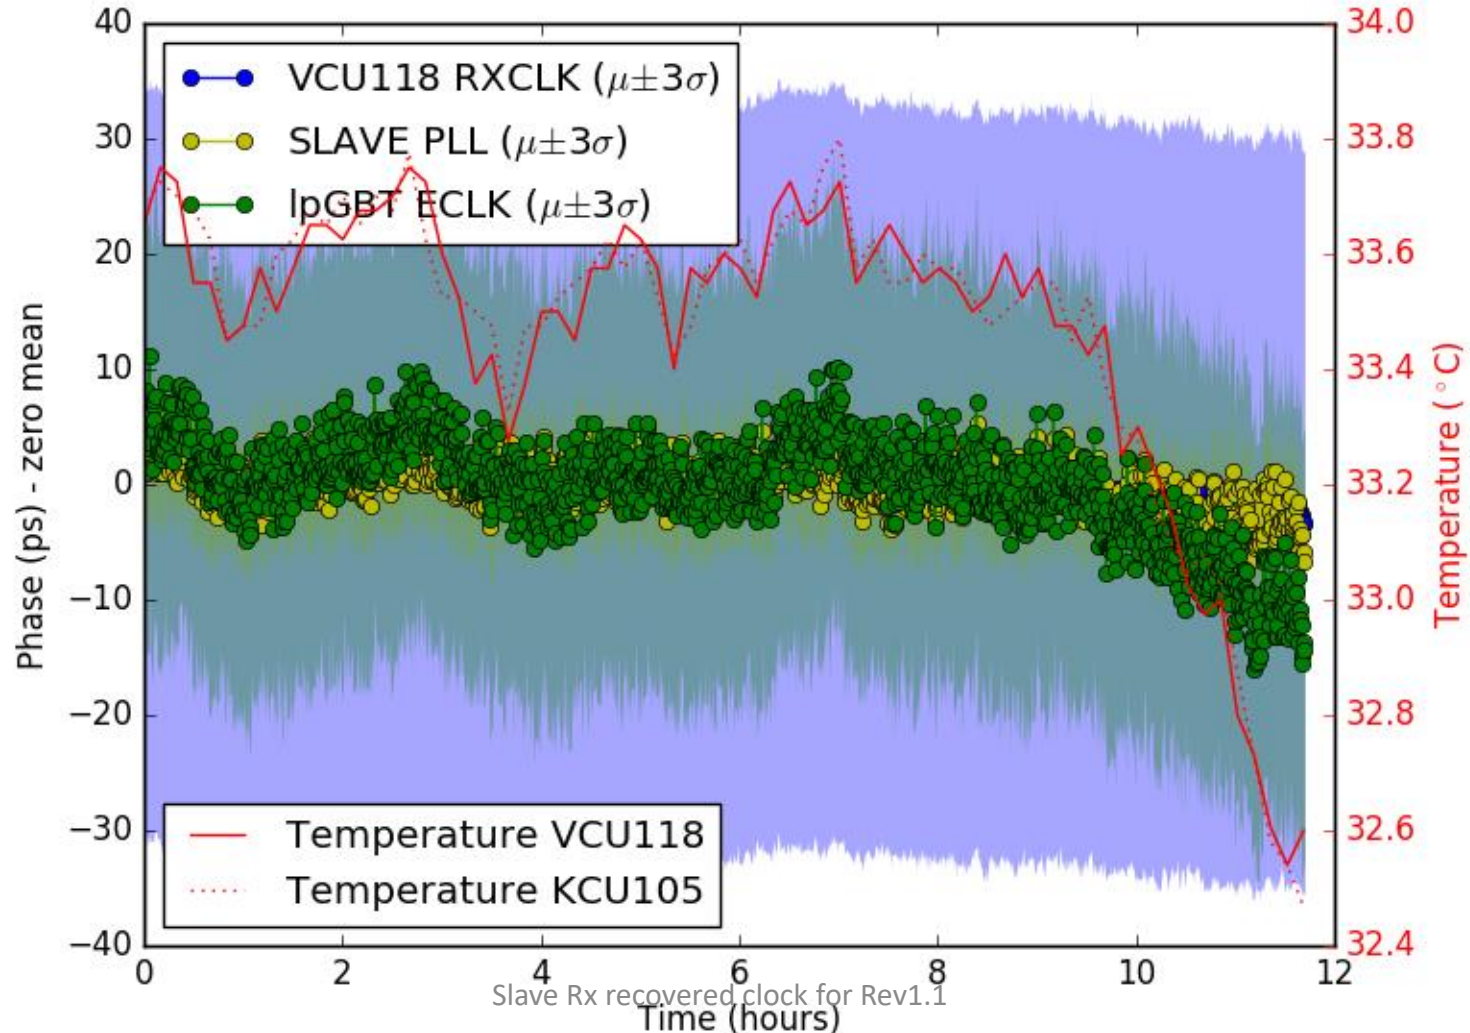
- Quite stable results overnight...
